**Nautical  
Archaeology  
Society**

# An Anchor with a Coded Inscription

Joost van den Besselaar and Peter Seinen

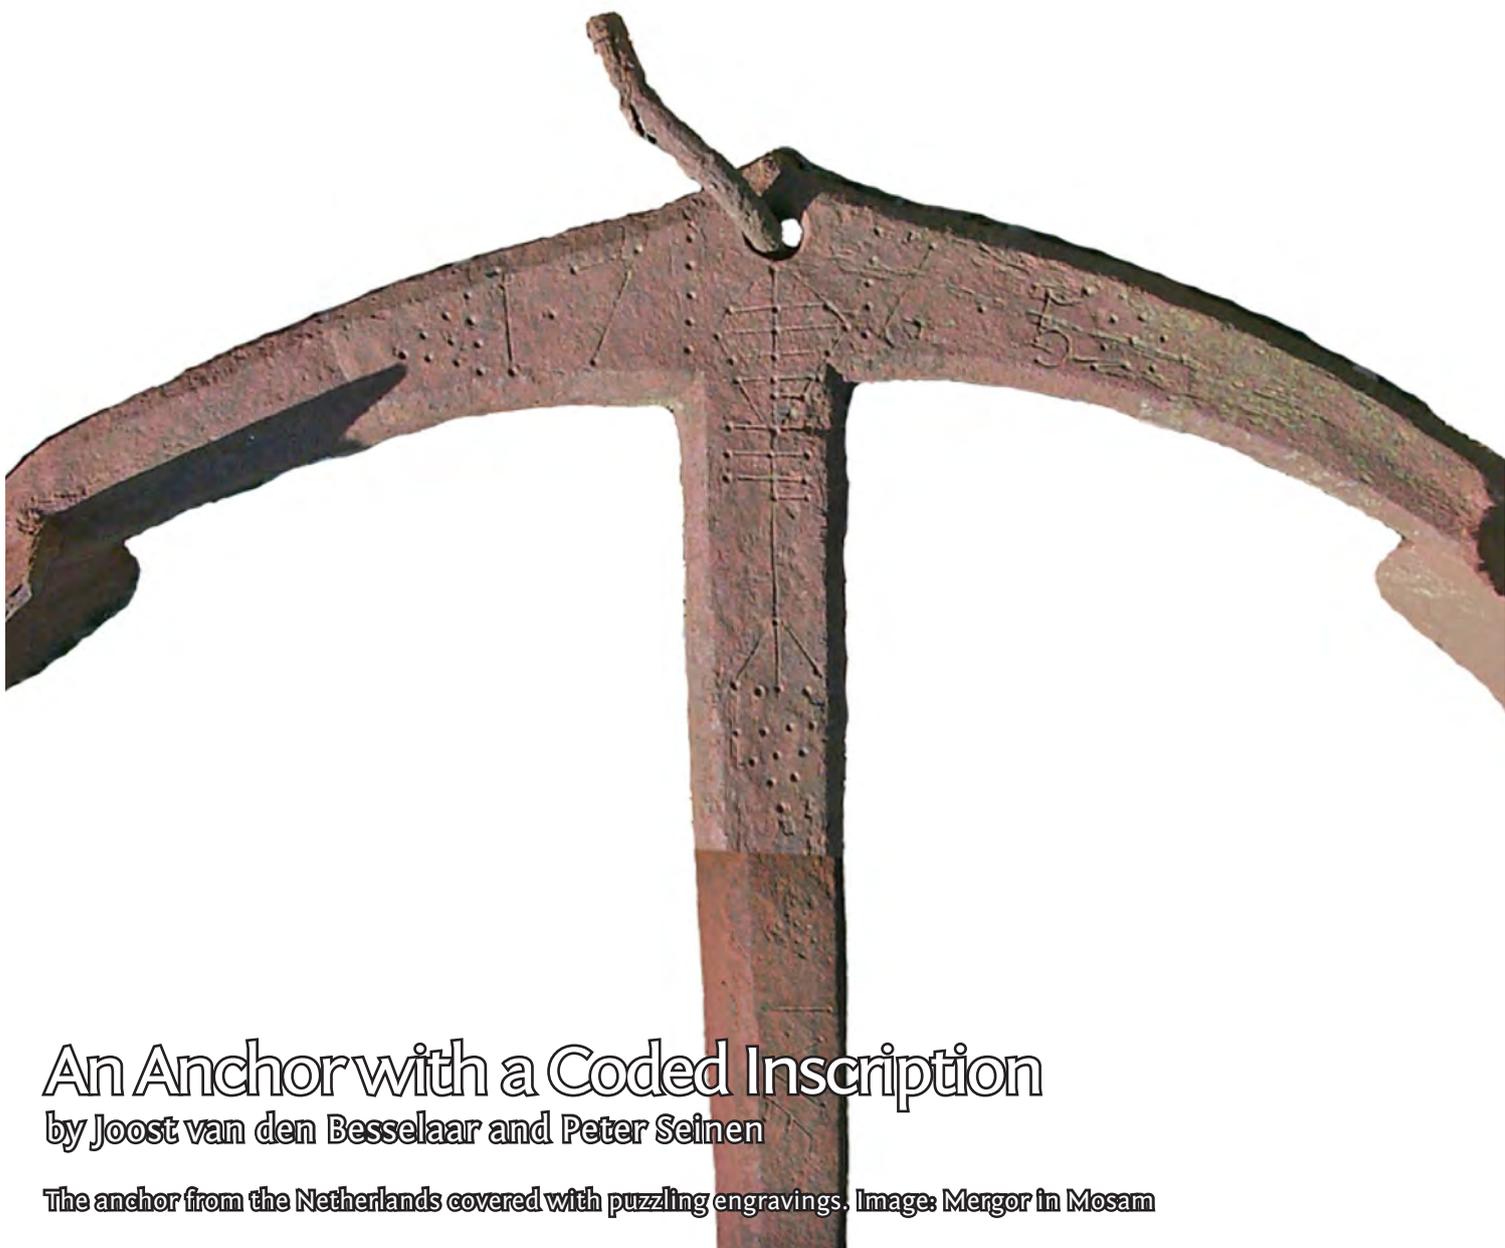
The anchor from the Netherlands covered with puzzling engravings. Image: Mergor in Mosam

The anchor measures 256x137 centimetres and weighs well over 250 kilogrammes. It is made of solid wrought iron and has a wooden stock. The fact that it is a remarkably large anchor makes

one wonder what kind of ship it had served. This size would indicate that anchor was used by a seagoing vessel, but the metal ring through the crown is tell-tale for river anchors, which is useful to 'free' the anchor when it is caught in tree trunks that litter the riverbed.

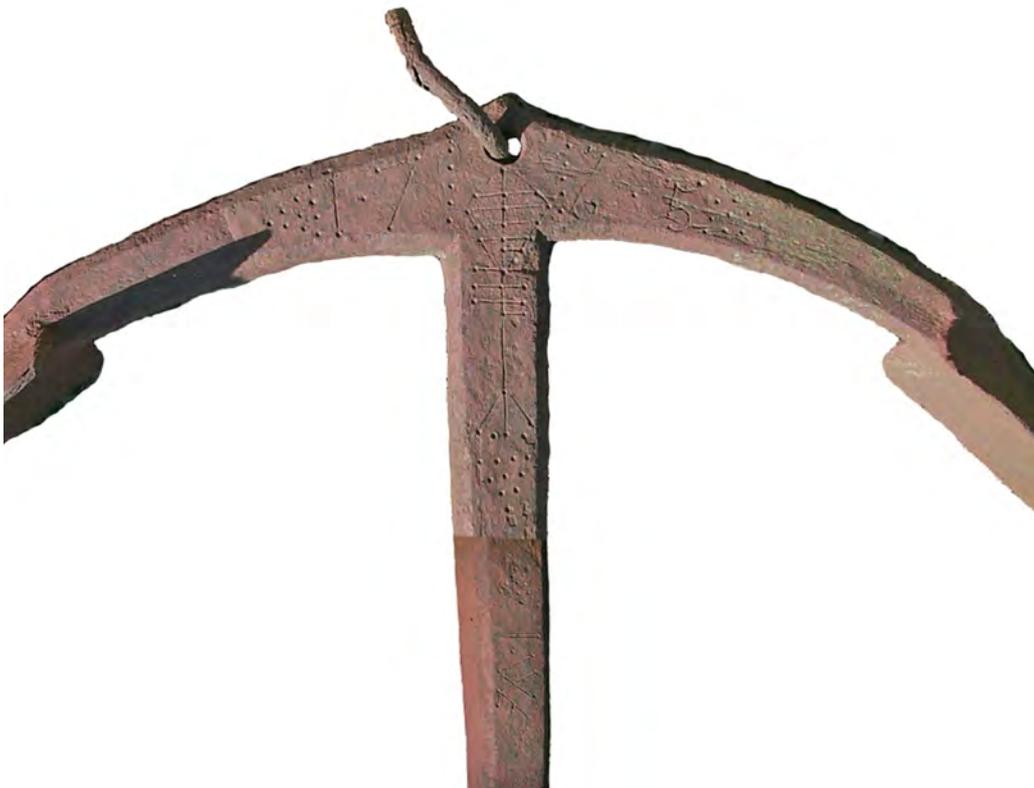
Shank, crown and arms covered with engravings. Image: Mergor in Mosam

Interestingly, in addition to the engraved date, there were some other intriguing marks on the surface of the shank, crown and arms of the find. The marks were made by the use of a steel chisel, which is the most convenient tool to make simple dents and lines on a metal surface. Most of the lines were first marked by small dents. What both these lines and dents mean is still debated.

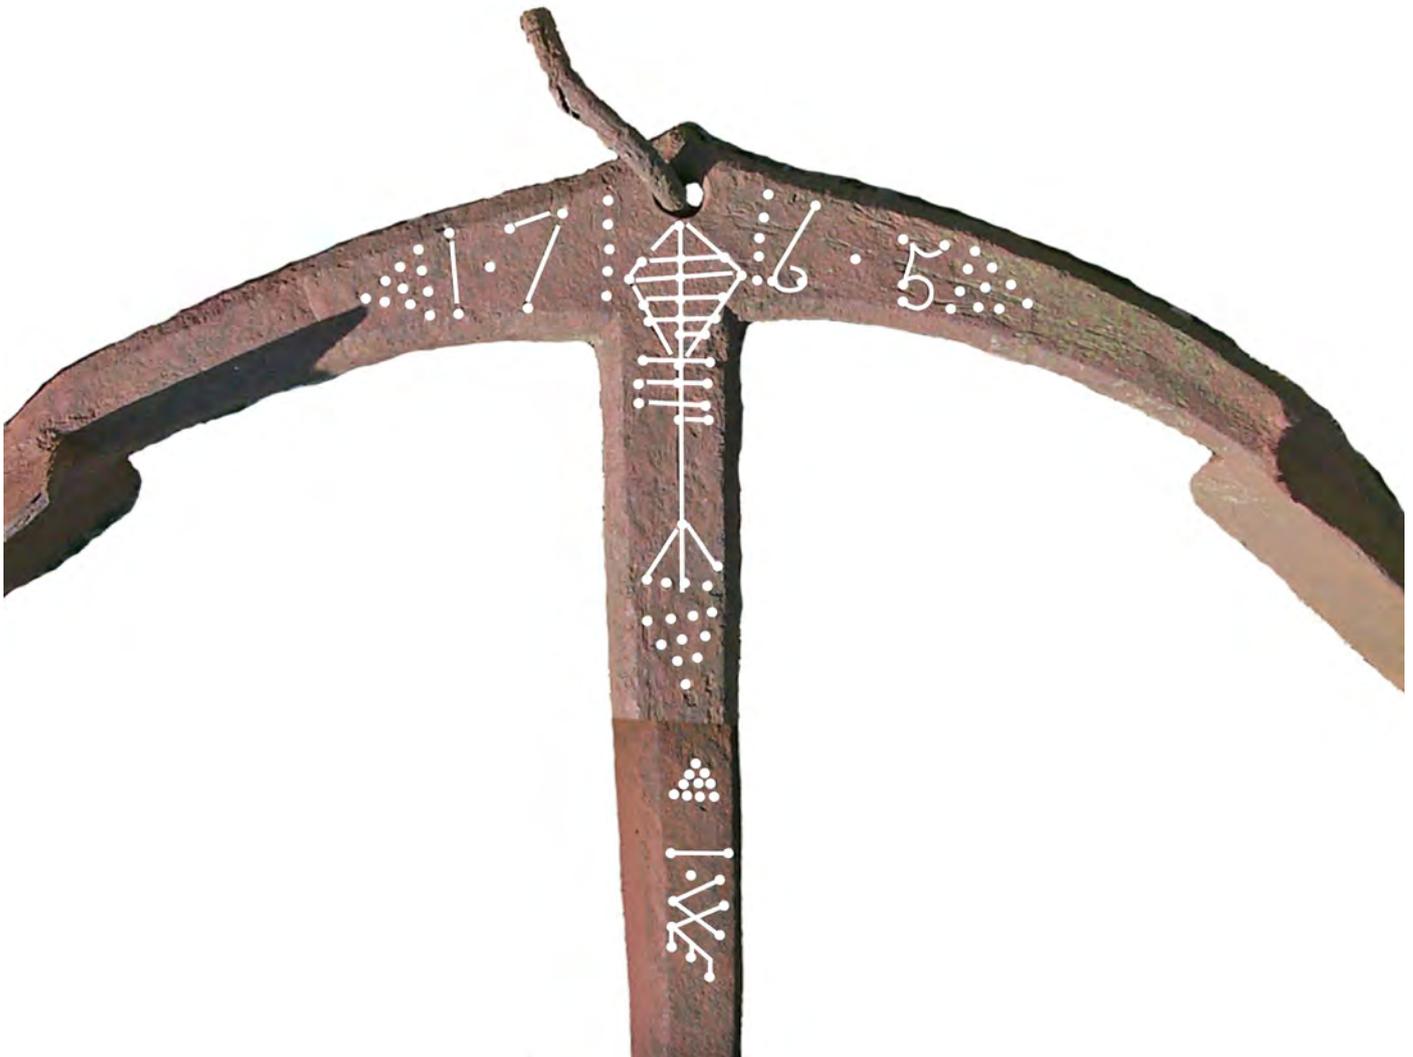
The engravings highlighted in white. Image: Mergor in Mosam

As for the engravings on our anchor we may distinguish three types: a) the plain engravings that include the production (?) date of the anchor '1765' and possibly the initials, if interpreted correctly, of the previous owner or manufacturer 'I.W.E'; b) the decorative dents that include the four pyramid-shaped clusters of 10 dents, the two rows of

five dents, and the two single dents; and c) the combination of dents and lines, which is difficult to interpret. In fact, the encoded engraving of dents and lines might be a designator of the manufacturer, the owner, or simply the weight of the anchor or the size of the ship it was designed for... opinions are currently divided on the matter.
